Center of Excellence for Advanced Technology Aerial Firefighting

Rapidly Deployable Data Network Report

CoE-19-003.1

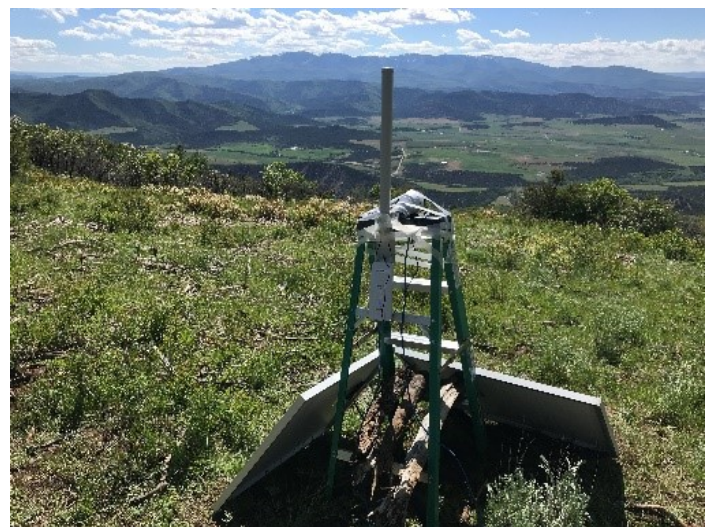
Figure 1—Mountaintop Radio Site During Test Deployment

The test deployment was successful and provided valuable lessons learned. Initially, two of the three hops in the network were deployed with omnidirectional antennas, with the third hop deployed using a highly directional dish antenna. The CoE found that the hop with a directional antenna on one end of the link performed much better than the hop with two omnidirectional antennas, even though the link distance was less than one-third the length of the link that included the directional antenna. Once the short hop was modified to include a directional antenna on one-half of the link, the system’s performance improved and the system was then able to provide Internet connectivity to the remote area and to stream a video feed from the remote mountaintop.

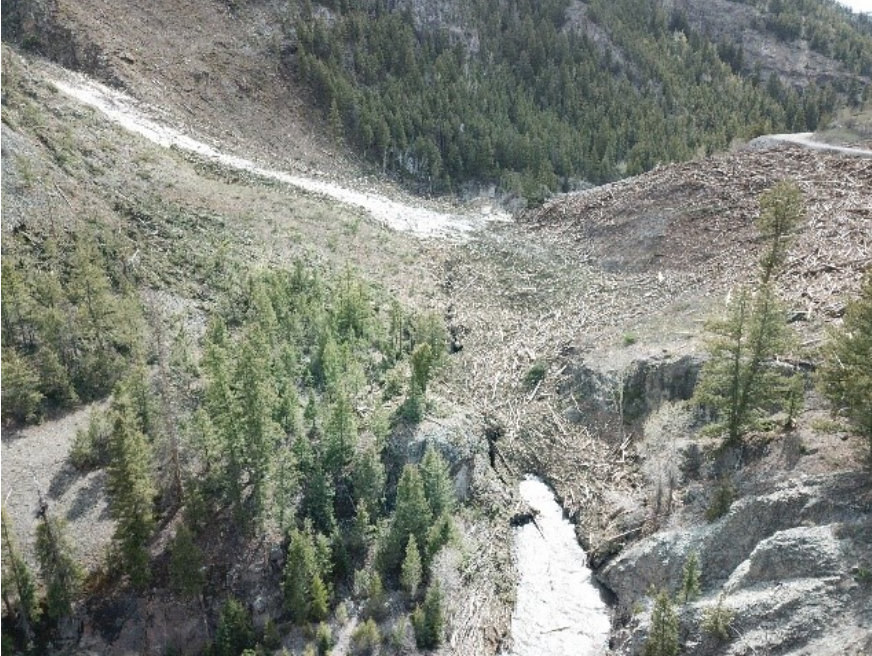
Figure 3—Treasure Mountain Slide

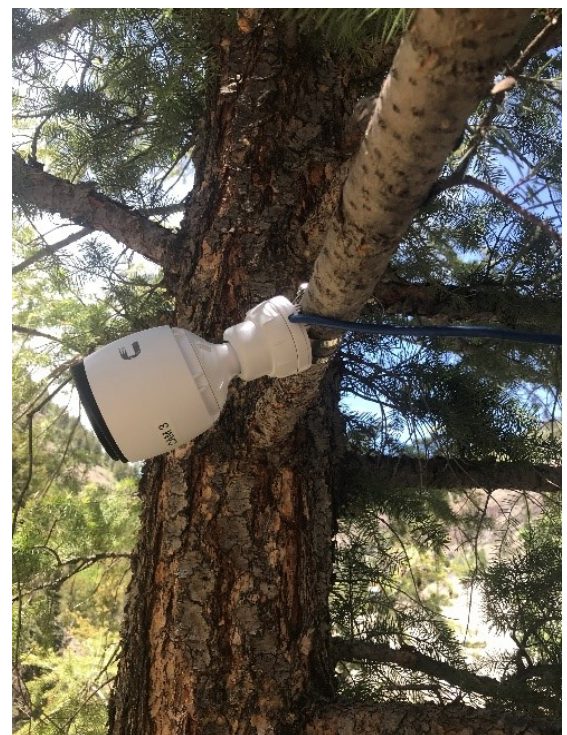
Figure 6—Camera Secured to Treelimb

three cameras: one looking downstream at the bulk of the avalanche slide, one looking upstream on Henson Creek, and one looking directly at the pool that had formed upstream of the avalanche. However, one of the cameras—a UniFi G3 Pro—experienced a hardware failure, so the crew ultimately set up two cameras: one looking downstream and one looking at the pool.

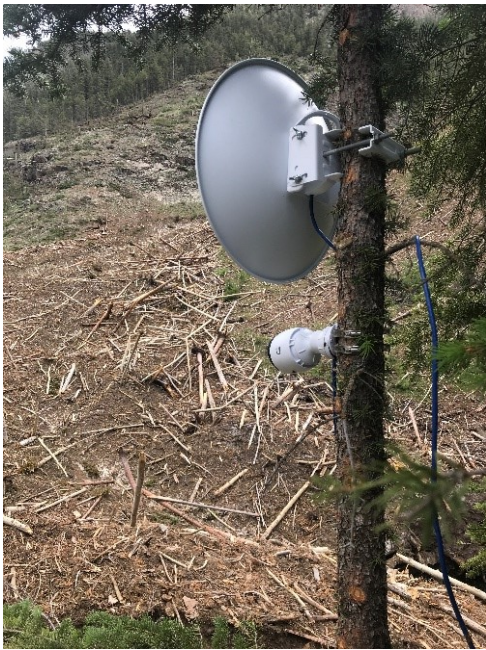
Figure 7—Equipment at Henson Creek

The crew then installed the node at the Treasure Mountain Slide on Henson Creek. This site lacks facilities, so the crew deployed a solar power setup consisting of a 180-watt solar panel, a 75-AH deep cycle battery, and Ubiquiti SolarPoint to charge the batteries and distribute power to the radio and cameras. The crew initially attempted to set up

At the Henson Creek site, a PowerBeam was used to link to Station Eleven mountain. The crew stripped several limbs from a spruce tree at the site and attached the radio directly to the tree. The summit of Station Eleven mountain was clearly visible when looking down the canyon and the PowerBeam was manually aimed in that direction. Both cameras were attached to trees and were connected to the SolarPoint by Ethernet cables. The PowerBeam radio was also connected by Ethernet to the SolarPoint controller. Finally, the Station Eleven site was deployed to complete the link. A landowner granted the crew access across private property to reach the summit and the crew erected the radio using a tripod that was staked to T-posts that had been driven into the ground. A solar setup was deployed at this location as well, and when powered up was able to establish a link to both the Sheriff's Office and the Henson Creek Site.

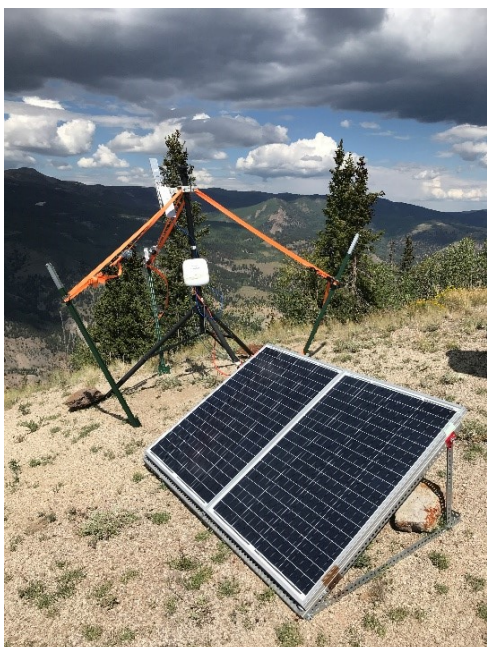
Figure 9—Equipment at Station Eleven Mtn

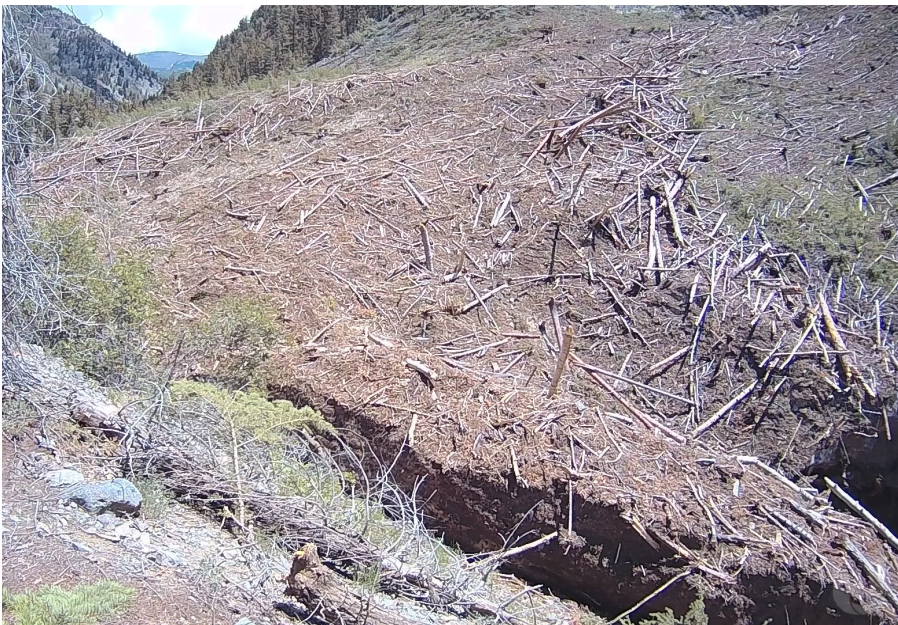
Figure 10—Camera's View of Slide on July 8th

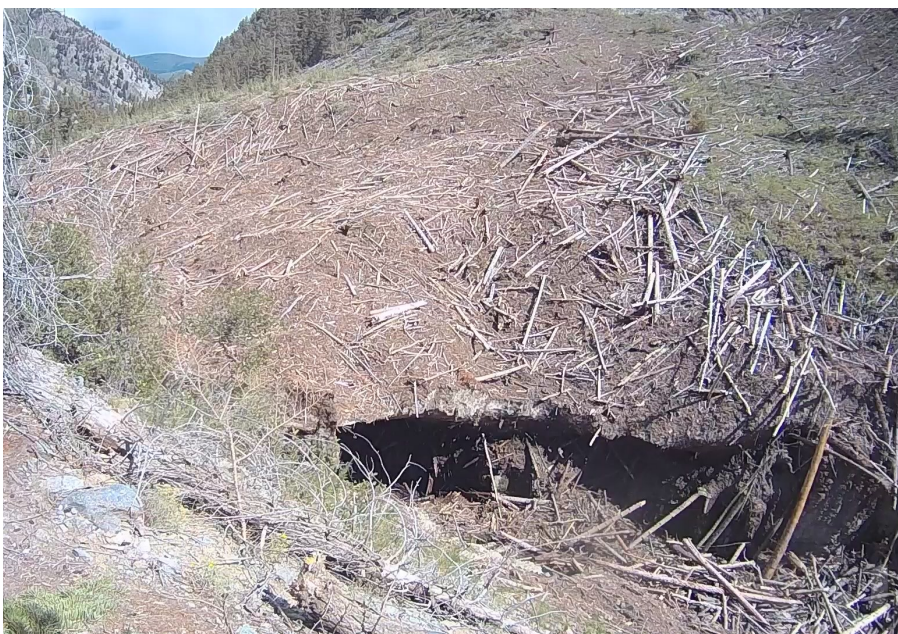
Figure 11—Camera's View of Slide on September 10th

On September 4, 2019, CoE personnel decommissioned the network and retrieved the equipment from Lake City. By this point, Henson Creek was much lower than in June and the threat of rapid flooding had significantly diminished. Amazingly, the Treasure Mountain Slide debris pile was still intact in September,

with hardened snow still covering the creek. Aside from the camera that initially experienced a hardware failure, all other equipment performed without issue and was quickly rehabbed and made available for other deployments.
